2007 Operations, Maintenance, and Monitoring Report

GIWW (GULF INTRACOASTAL WATERWAY) to CLOVELLY HYDROLOGIC RESTORATION

State Project Number BA-02 Priority Project List 1

August 6, 2007 Lafourche Parish

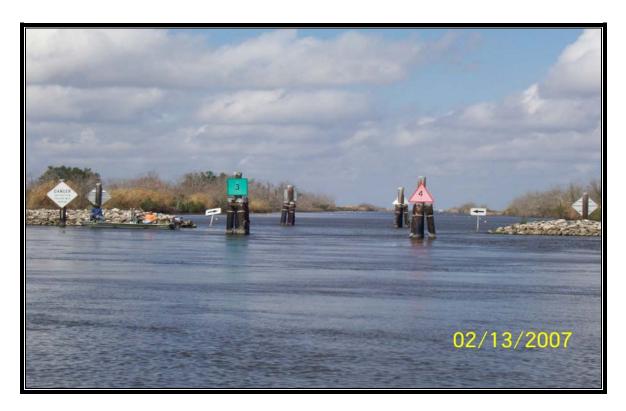
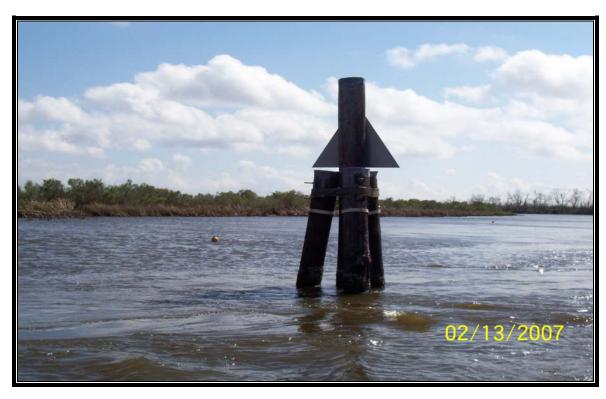
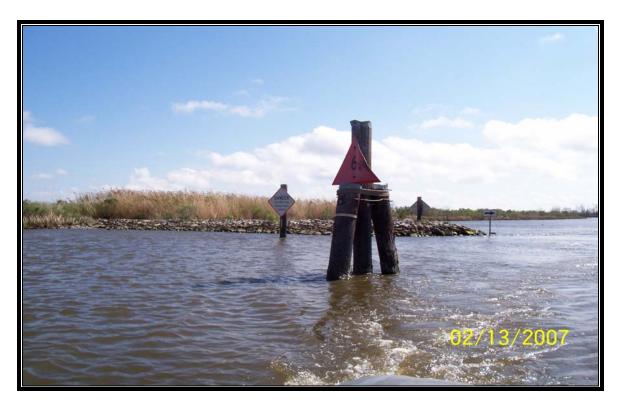
The rock weir structure with barge bay at Structure No.1 appeared to be in good condition with no noticeable settlement along the length of the structure. The signs, supports, and earthen embankment tie-ins were also in good condition. As noted on previous inspections, we observed that several of the timber pile clusters on each side of the barge bay supporting the navigation aids and signage were slightly damaged and scarred from large vessels rubbing the timbers while accessing the barge bay. Although there is visible damage to the timber pile supports, LDNR and NRCS do not believe that the structural integrity of the pile supports are compromised by the damage present. The inspection team will continue to monitor the condition of the timber dolphin system. (Appendix B, Photos 1–3)

Photo No. 2 – (Structure No.1) – view of slight damage to timber pile cluster at Structure No.1.

Photo No. 3 – (Structure No. 1) – view of timber pile cluster located on the northeast side of the structure.

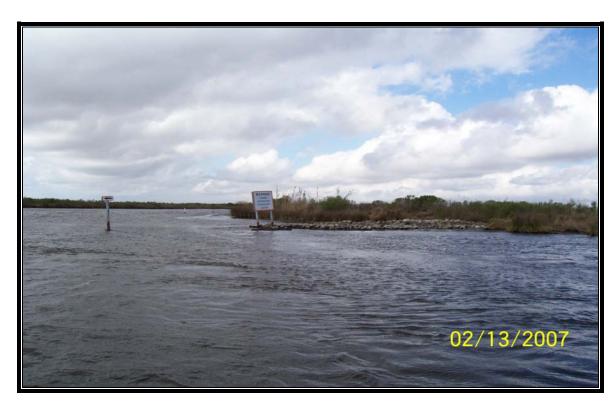
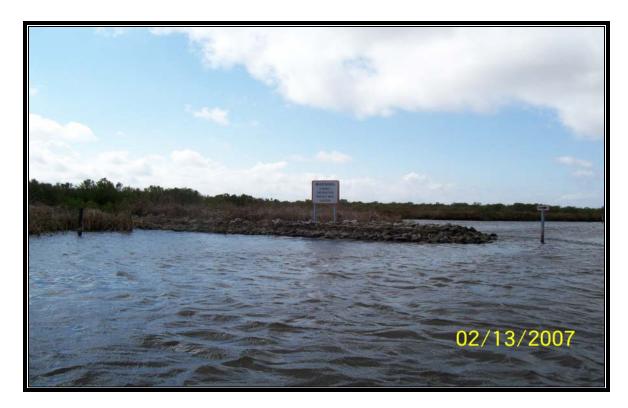
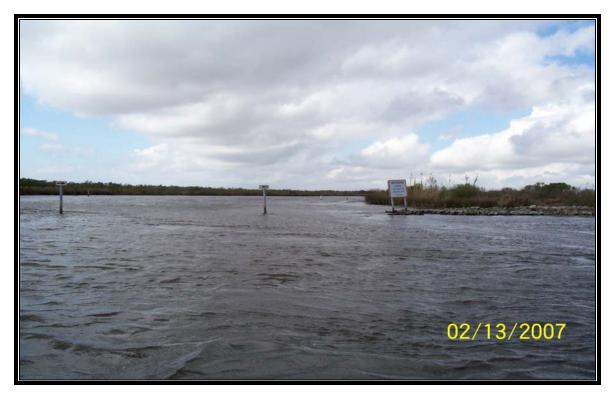
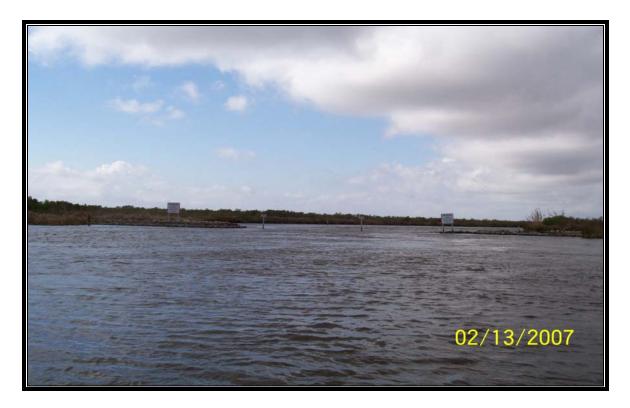
The rock weir at this location appeared to be in fair condition with moderate settlement on the north side of the structure. The south side of the weir was in good condition with no noticeable change from previous inspections. Signs and supports were also in good condition with no obvious damage. The inspection team will continue to monitor the condition of the north side of the weir. (Appendix B, Photos 4–7)

Photo No. 4 – (Structure No. 2) – north side of rock weir with boat bay looking east.

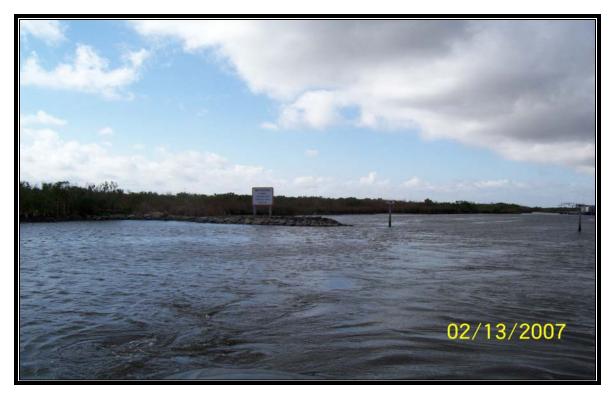
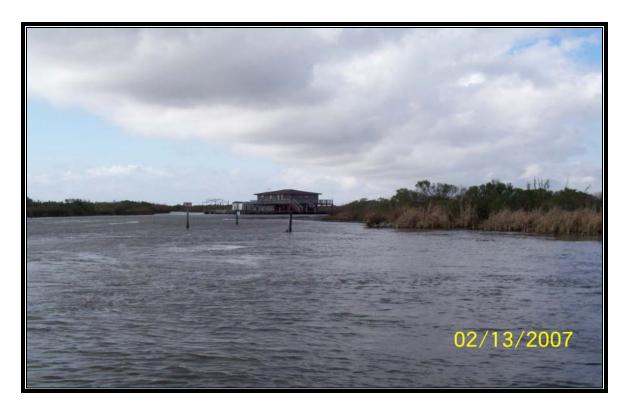
As documented on previous inspections, the north side of the rock weir had experienced severe settlement, below the elevation of the waterline estimated at 0.0 ft (0.0 m) NAVD88 at the time of the 2007 inspection. The warning sign installed in the center of the rock dike on the north side was missing. The south side of the rock weir appeared to be in good condition with no apparent change from the previous year's inspection. (Appendix B, Photos 8 and 9)

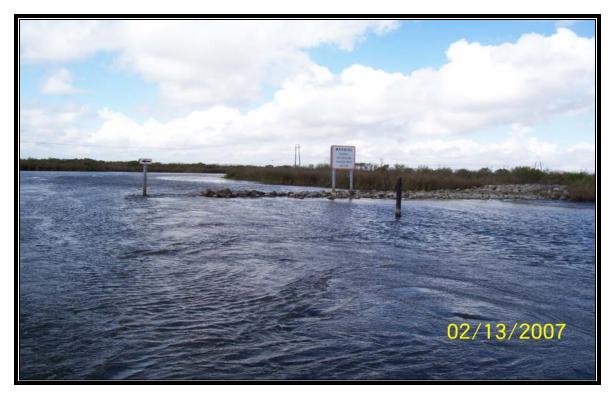
As reported on previous inspections, the south side of the structure had settled some since the rock weir was completed in 1997. It appears that settling has stabilized over the past few years with no noticeable change from the previous inspections. The signs and supports remain intact and are in good condition. (Appendix B, Photo 10)

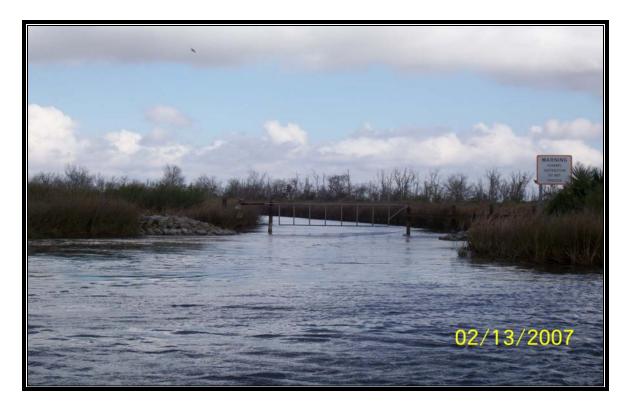
The small rock weir and earthen embankment tie-ins located adjacent to Structure No. 7 behind an existing camp was in good condition with no signs of damage or settlement. The gate crossing the boat bay and signage were also in good condition. (Appendix B, Photo 11)

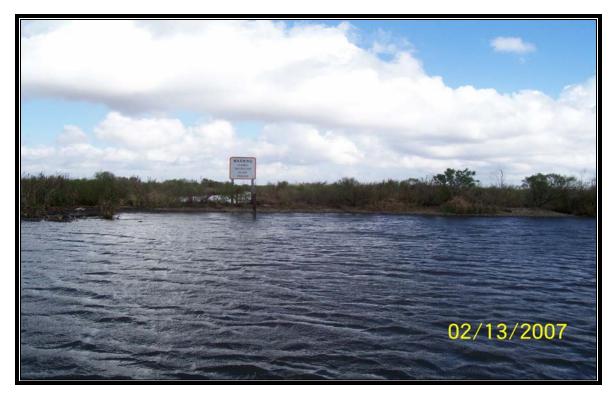
On previous inspection cycles, it has been documented that a 10 ft (3 m) wide section of the rock plug was breached on the east side of the structure, allowing water exchange from the canal to the interior marsh during high water events. It appears that this section of the rock plug has stabilized and no exchange of water was noticed during the 2007 inspection. Due to the low elevation of the earthen banks along the channel adjacent to the structure, there would possibly be little benefit in repairing the structure since the marsh would flood on high water events, bypassing the rock plug. (Appendix B, Photo 12)

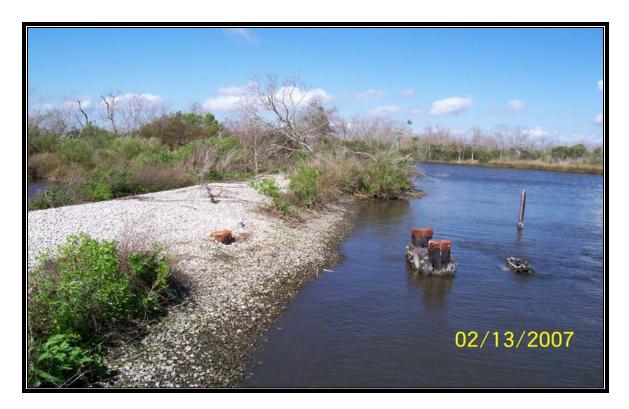
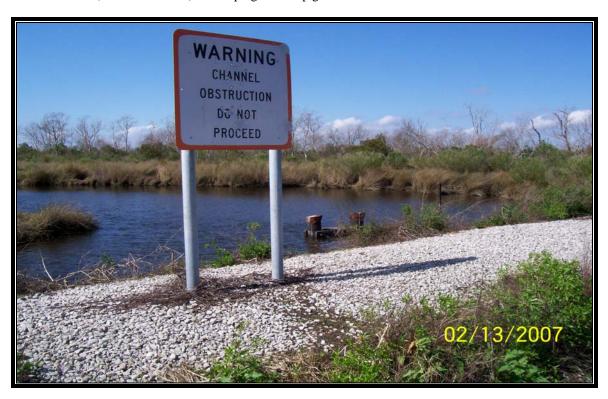
The rock plug at this location appeared to be in very good condition with no settlement or displacement of ri rap. The signs and supports along the structure were also in good condition. An inspection of the corrugated culvert and flap gated structure through the plug revealed moderate corrosion and excessive barnacle growth in and around the gate. The presence of barnacle growth in and around the gate does not appear to be affecting the gate operations. (Appendix B, Photos 13 and 14)

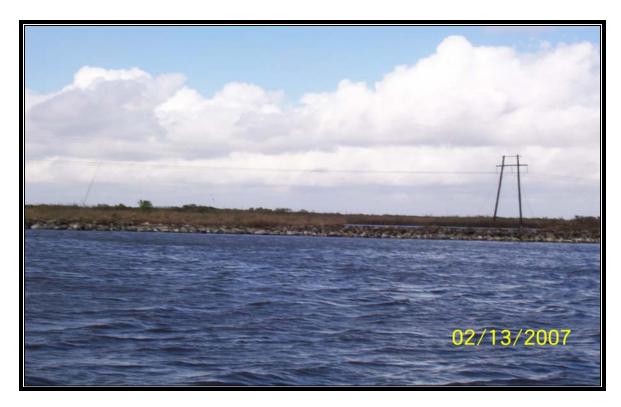
The channel plug along the west bank of Little Lake appeared to be in good condition with no visible damage or structure settlement. The marsh on both sides of the structure appeared to be thin with very little stable marsh remaining near the marsh tie-ins. From 2005 post storm assessments, this area experienced high erosion rates during Hurricanes Katrina and Rita, exposing the structure to potential breaching at both ends. The inspection team will continue to monitor the erosion and marsh conditions in this area. (Appendix B, Photo 15)

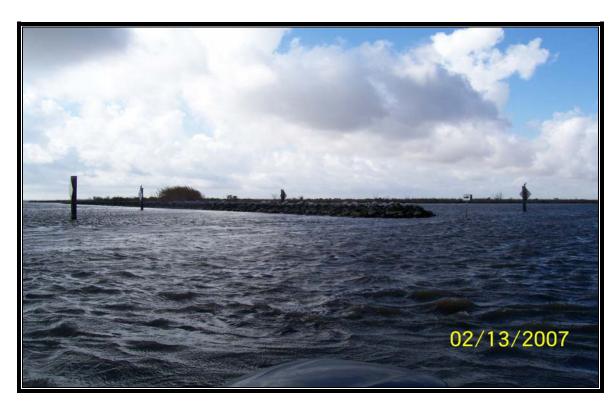
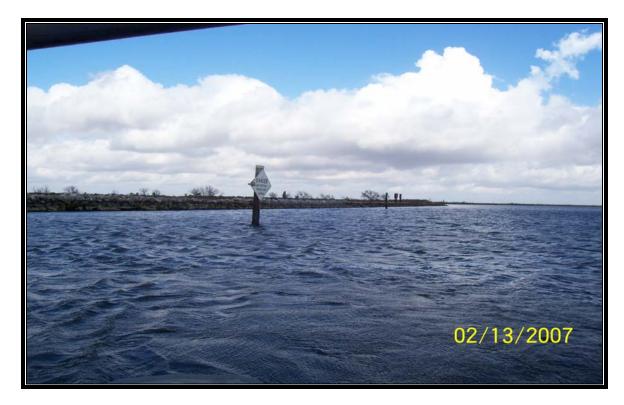
The rock weir with barge bay along Clovelly Canal was in good condition with no visible settlement or damage. However, a small section of the rock weir near the south end of the barge bay was displaced during the 2005 hurricane season, leaving a gap at the opening of the barge bay. The inspection team agreed that the damage is minor and will not affect the integrity of the structure or alter the overall performance of the project. As noted in previous reports, the

We did note that one (1) of the timber pile clusters on the northwest side of the structure was struck by a vessel accessing the barge bay, leaving a longitudinal crack in the timber piling. The inspection team is confident that the damage to the timber piling will not affect the integrity of the timber dolphin and do not believe that maintenance or replacement of the piling is necessary at this time. The inspections, diagnostic testing, and maintenance repairs of the four (4) navigational aids at this location have been contracted to Automatic Power, Inc. of Larose. The maintenance contract period began in January 2007 and will continue through January 2010. (Appendix B, Photos 16 and 17)

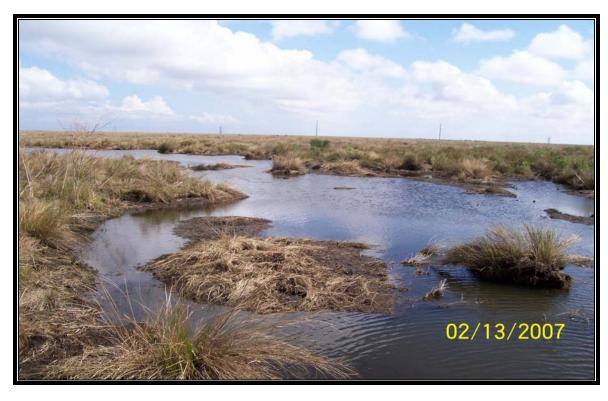
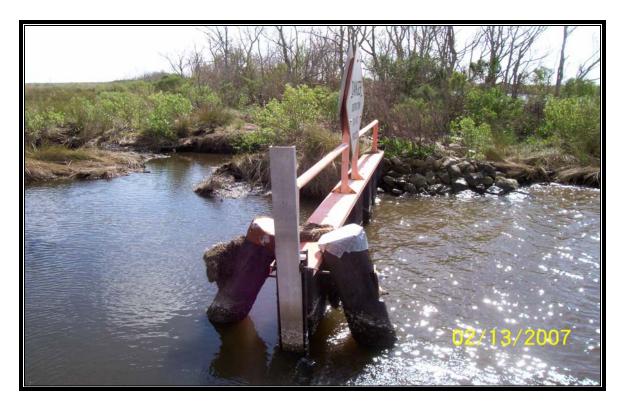
The variable crest weir structure was in good condition with minor paint chipping along the channel cap and hand railing on the bulkhead and walkway. The lifting boom was operational and signage in good condition. The stop logs have not been adjusted since 2005 due to large sections of marsh blocking the conveyance channel to the interior marsh as a result of Hurricane Katrina. LDNR-TFO has prepared plans and specifications to clean out marsh material blocking the channel beginning at Structure No. 35 and repair three (3) breaches in the spoil bank along existing oilfield location canals between Structures No. 35 and No. 91 near the southern boundary of the project area. Construction should begin sometime in late summer. Normal operations will continue once the marsh plug is removed and hydrologic connections are reestablished. (Appendix B, Photos 18 and 19)

Photo No. 18 – (Structure No. 35) – view of marsh plug behind Structure No. 35 along oilfield location canal.

Scheduled structure operations in September 2005 were canceled due to damage caused by Hurricanes Katrina and Rita. A maintenance project has been initiated by LDNR to remove large sheets of marsh blocking the conveyance channel behind Structure No. 35, prohibiting flow through the weir. Normal structure operations will resume upon completion of the maintenance project in December 2007.

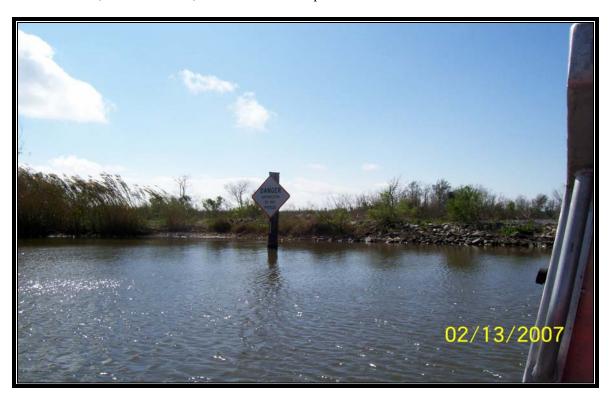
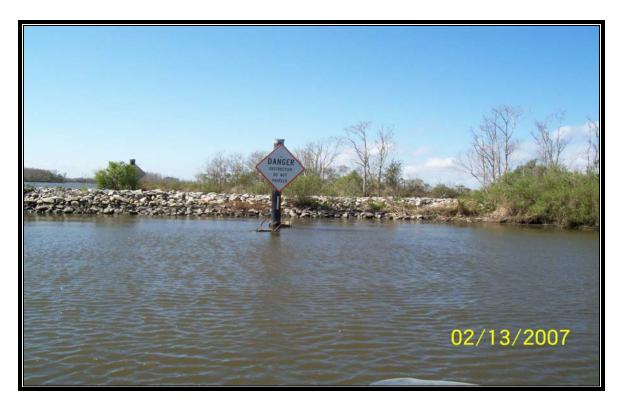
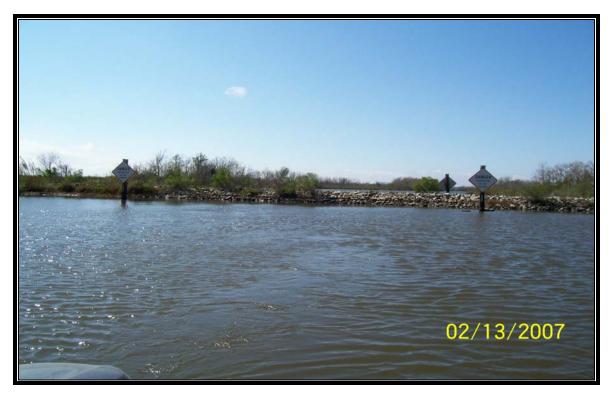
The rock plug at this location is in very good condition, with no settlement or displacement of riprap. The signs and timber supports are also in good condition. No maintenance required at this time. (Appendix B, Photos 20–22)

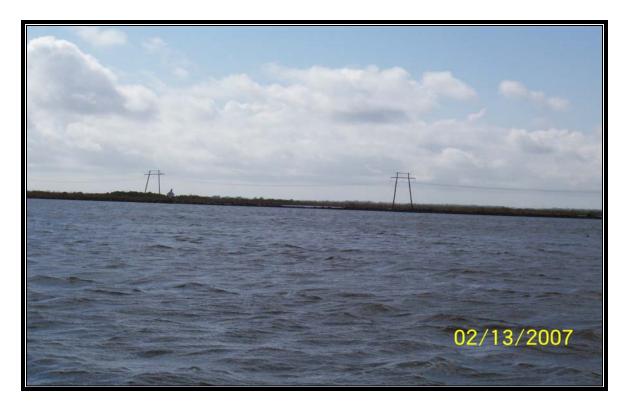
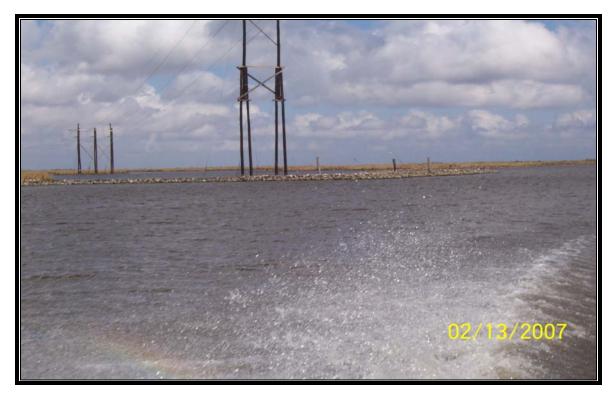
As noted on previous inspections, we observed several areas along the rock dike of the lake rim that have settled below the design elevation. Areas with moderate settlement are Sta. 7+00 to Sta. 13+00 at approximately 1.5 ft (0.5 m) NAVD88, and 36+00 to 41+00 from 1.0 ft to 1.5 ft (0.3 m to 0.5 m) NAVD88. The original armored rock dike was constructed to an elevation of +2.0 ft (+0.6 m) NAVD88. Due to the settlement of the lake rim and rock weirs observed over the past several years, we are recommending a profile survey to evaluate the extent of settlement prior to the 2008 annual inspection. Once this data is collected, an informed decision can be made regarding maintenance needs of all rock features within the GIWW to Clovelly Hydrologic Restoration (BA-02) project. (Appendix B, Photos 23 and 24)

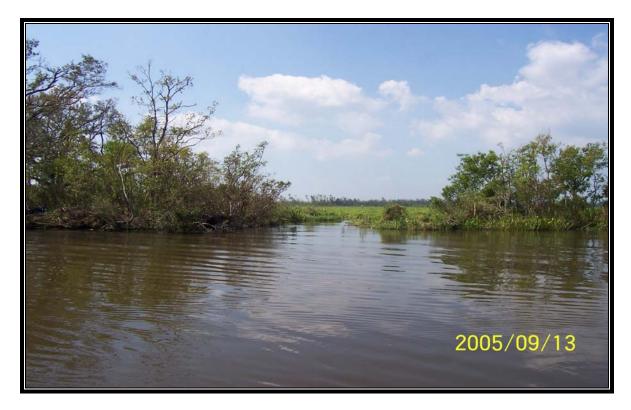
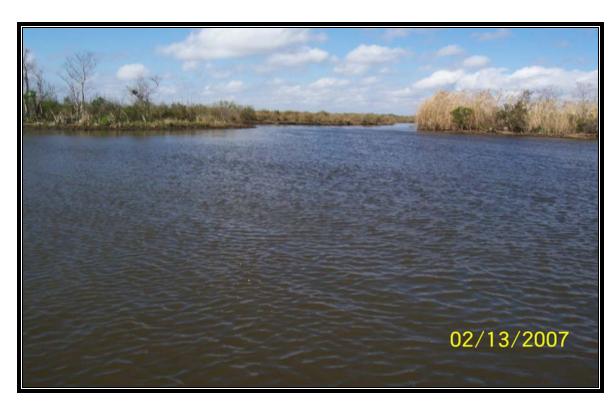
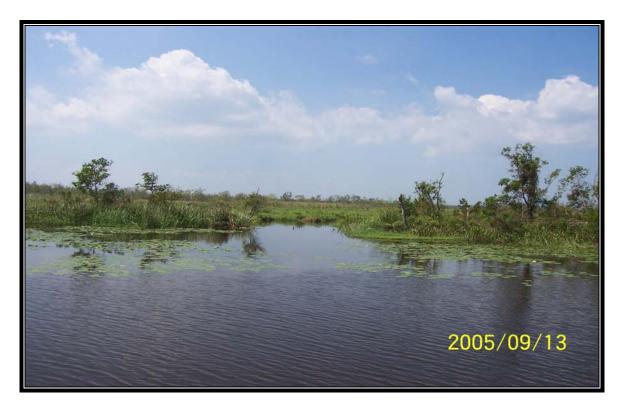
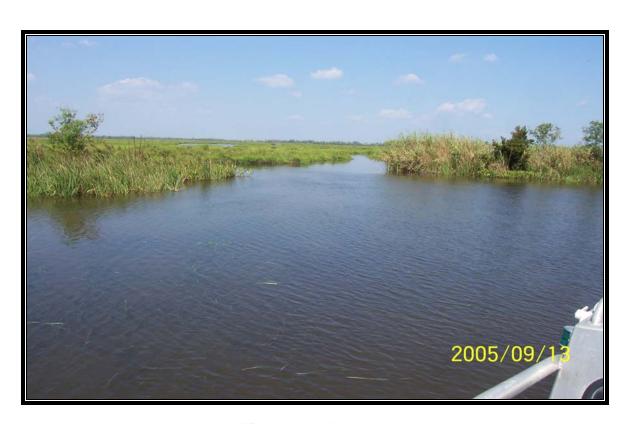
Overall, the earthen embankment constructed along several oilfield canals near the southern boundary of the project appeared to be in good condition, with the exception of four (4) breaches

identified during the post storm inspections completed in late 2005. The four (4) breaches are located in the southern portion of the project area and range between 10 ft (3.0 m) and 30 ft (9.1 m) wide. The LDNR-TFO is currently finalizing plans and specifications and acquiring necessary permits to repair these breaches and clean out marsh debris behind Structure No. 35. (Appendix B, Photos 25–28)

Immediate maintenance recommendations resulting from the 2007 inspections include repairing four (4) breaches in southern project area resulting from Hurricanes Katrina and Rita and cleaning out marsh material behind Structure No. 35 to open the conveyance channel to the interior marsh. These repairs are included in a maintenance project initiated by LDNR and should be completed by December 2007.
